# **INDOOR AIR QUALITY ASSESSMENT**

**Graham and Parks School  
44 Linnaean Street  
Cambridge, MA 02138**

Prepared by:  
Massachusetts Department of Public Health  
Bureau of Environmental Health  
Indoor Air Quality Program  
December 2016

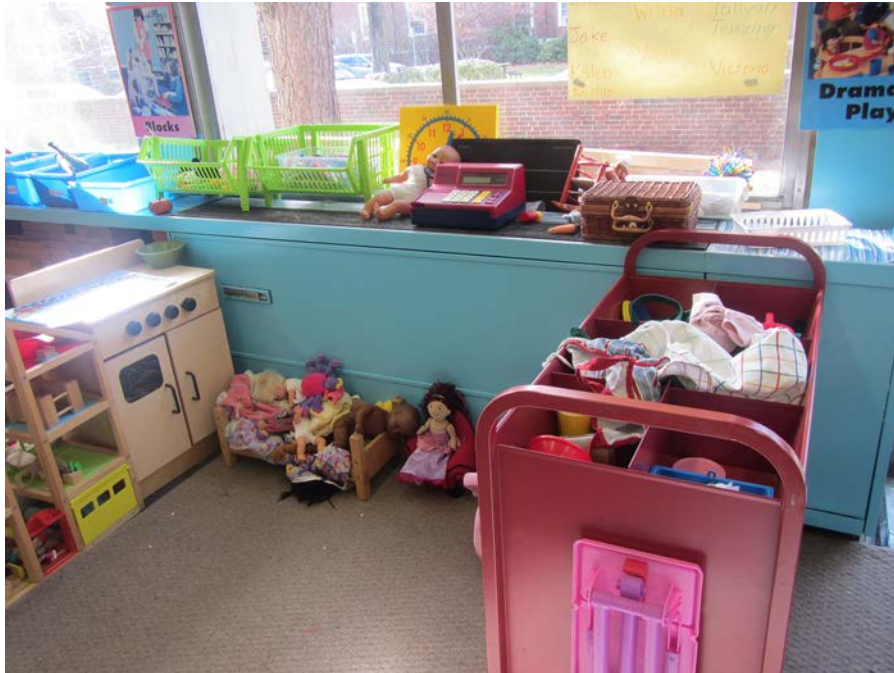
**Picture 1**

Univents were found deactivated in classrooms throughout the school. Obstructions to airflow, such as papers and books stored on univents and bookcases and/or carts and desks located in front of univent returns, were observed in a number of classrooms (Picture 1). In order for univents to provide fresh air as designed, intakes must remain free of obstructions; importantly these units must remain “on” and allowed to operate while rooms are occupied. Some items on top of or near the univent (e.g. plastic, crayons) can become sources of odor when heated.

**Classroom univent, note items placed on top and in front of unit**

2. Remove all blockages from univents and exhaust vents to ensure adequate airflow. Ensure plastic and wax-based products are not placed on top or in front of univents.

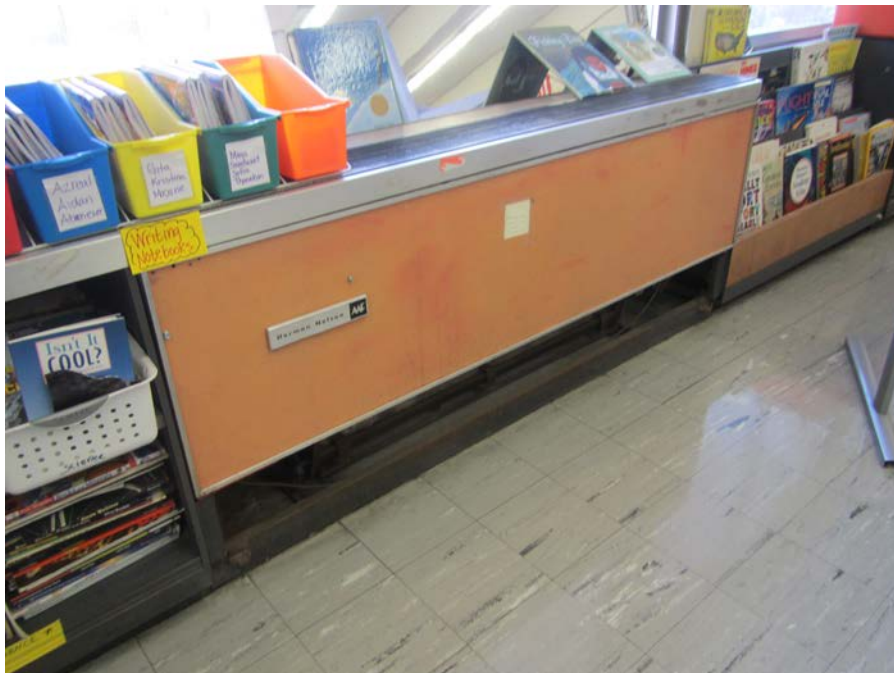
**Picture 2**

Fresh air in classrooms is supplied by unit ventilator (univent) systems (Pictures 1 and 2). Univents draw air from outdoors through a fresh air intake located on the exterior walls of the building (Picture 3) and return air through an air intake located at the base of each unit ([Figure 1](#)). Fresh and return air are mixed, filtered, heated, and provided to classrooms through a fresh air diffuser located in the top of the unit. Each univent has a fiber filter that is reportedly replaced every 6 months. BEH staff spot checked filters in a few areas. While filters appeared new, dust and debris were noted within the unit's air chamber (Picture 4). Please note, some univents were also missing paneling (Picture 2).

**Classroom univent, note missing panel**

3. Replace missing univent cabinet panels/diffusers; have new ones fabricated if necessary.
4. Ensure univent cabinets and air chambers are cleaned/vacuumed periodically to prevent aerosolization and distribution of dust and debris. Ensure filters fit flush in their racks with no spaces in between allowing bypass of unfiltered air into the unit.

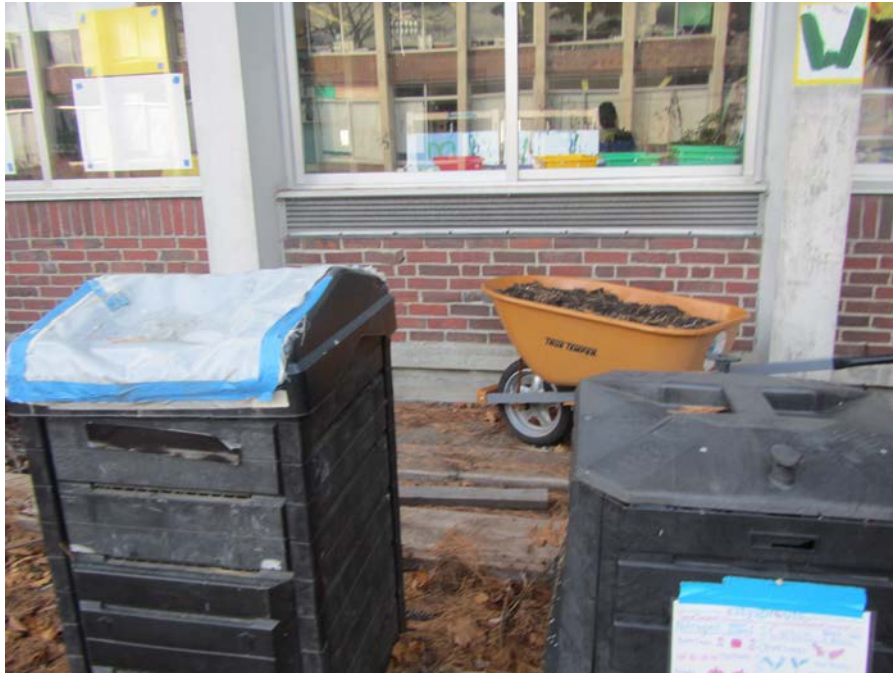
**Picture 3**

A compost bin was noted outside, near the univent fresh air intake for classroom 105 (Picture 3). This bin should be relocated away from fresh air intakes to prevent entrainment of odors. Measures should be taken to ensure that any compost bins are stored in an appropriate place and functioning properly.

**Univent fresh air intake, note wheel barrel and compost bins in proximity**

20. Move the compost bins away from any fresh air intakes. Examine compost bins periodically to ensure odor control.
21. Eliminate the use of scented items, including air deodorizing sprays and plug-ins to prevent respiratory irritation.

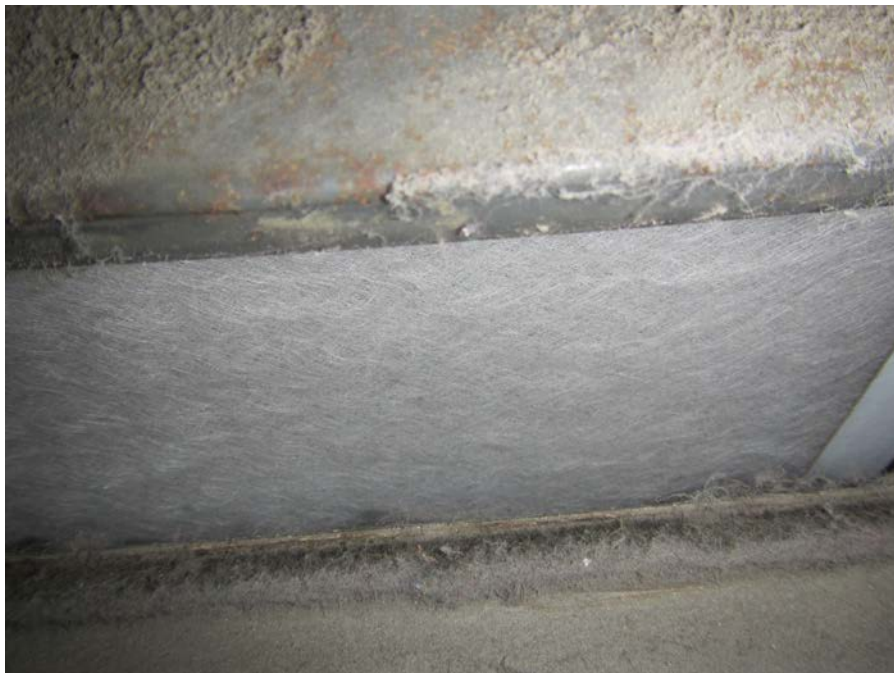
**Picture 4**

**Univent filter, note dust/debris within univent air chamber**

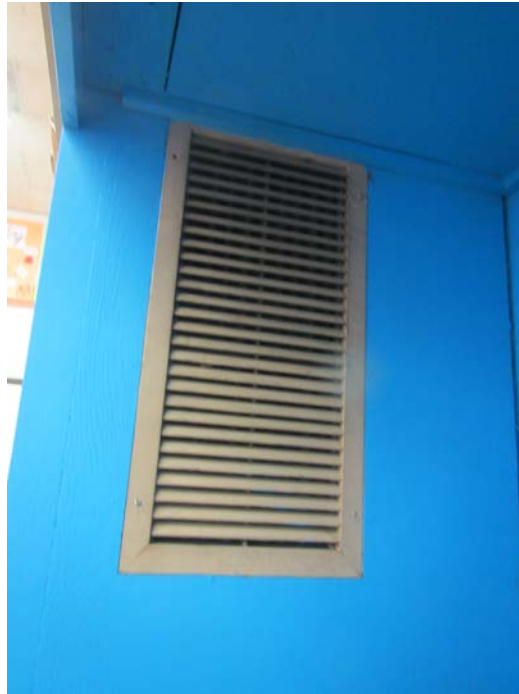
**Picture 5**

Exhaust ventilation in classrooms is provided by vents located in the upper interior wall of open closets (Picture 5). These vents are connected to rooftop exhaust fans. These fans were not operating at the time of assessment, which prevents removal of normally-occurring indoor air pollutants. The location of the exhaust vents makes it easy for the vents to be blocked by stored materials (Picture 6). In a number of classrooms, these vents were blocked with books, backpacks, and boxes. In order to function properly, these vents must remain free of obstructions.

**Classroom exhaust vent located in closets**

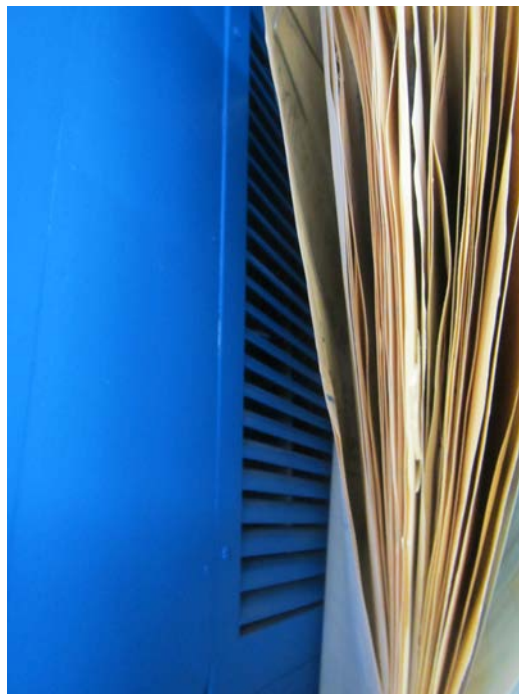
**Picture 6**

**Classroom exhaust vent blocked by files**

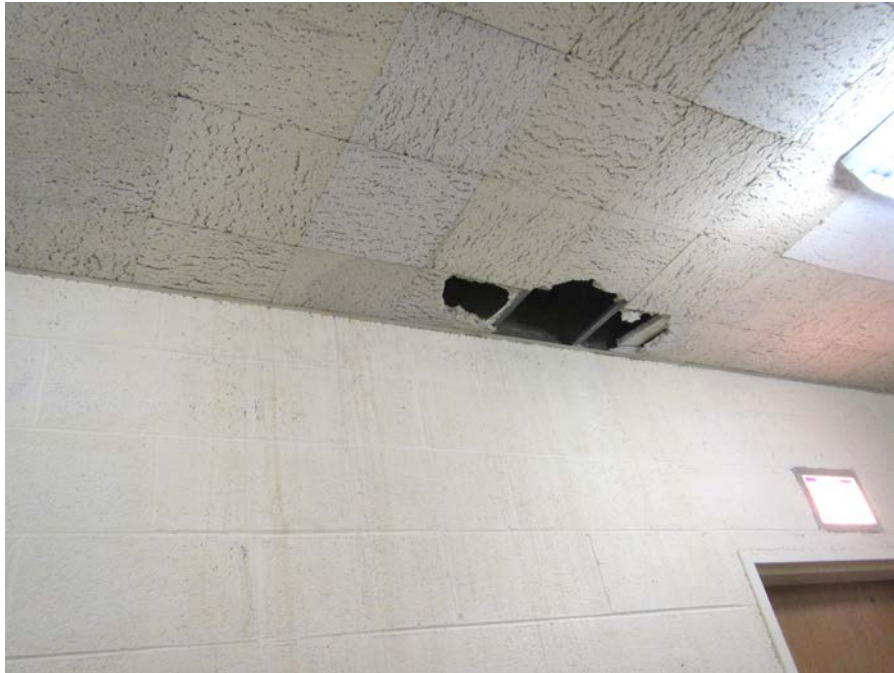
**Picture 7**

A roof leak was reported in space leased to a local theatre group, as well as in a shared hallway. This space is accessed by a stairwell in the gymnasium, as well as a hallway to the rear of the auditorium where student instruments are stored. Water-damaged interlocking ceiling tiles were observed in the hallway (Picture 7). Standing water (Picture 8) and musty odors were noted in the stairwell leading down towards the boiler room. At the time of assessment, Michael Lane, Director of Facilities, indicated that water-damaged ceiling tiles would be replaced.

**Water-damaged interlocking ceiling tiles**

10. Repair roof/plumbing leaks and replace stained ceiling tiles.
11. Replace missing ceiling tiles to prevent the egress of dirt, dust, and particulate matter into classrooms. Consider using water-catching ceiling tile to collect water for persistent leaks. Ensure water catching receptacles are emptied daily and cleaned to prevent odors.

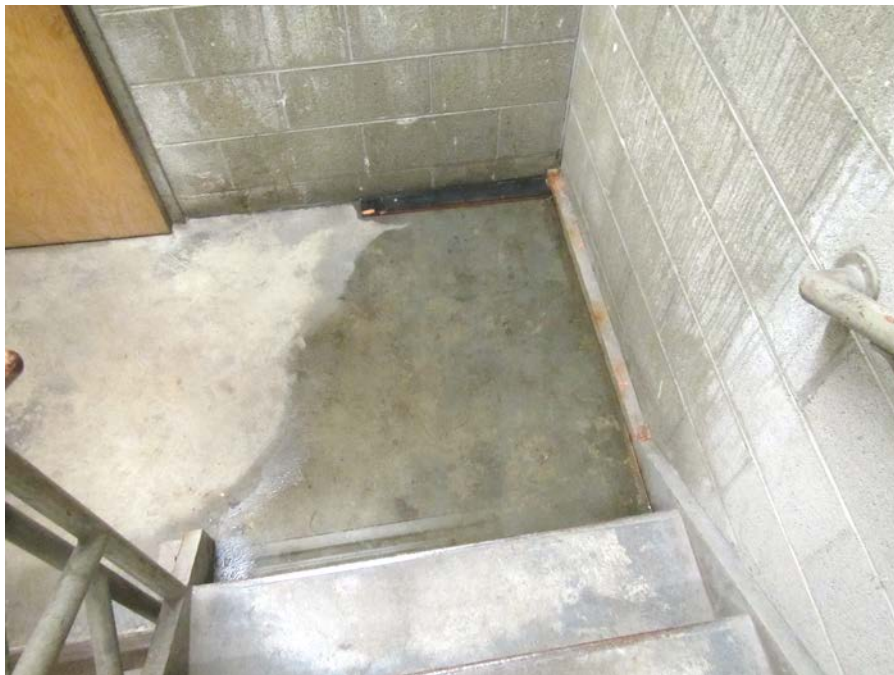
**Picture 8**

**Standing water in stairwell to boiler room**

14. Ensure standing water is removed from the stairwell to the basement. Consider using fans to remove air from the stairwell and into the boiler room as a method for drying the stairwell and reducing odors to the area.

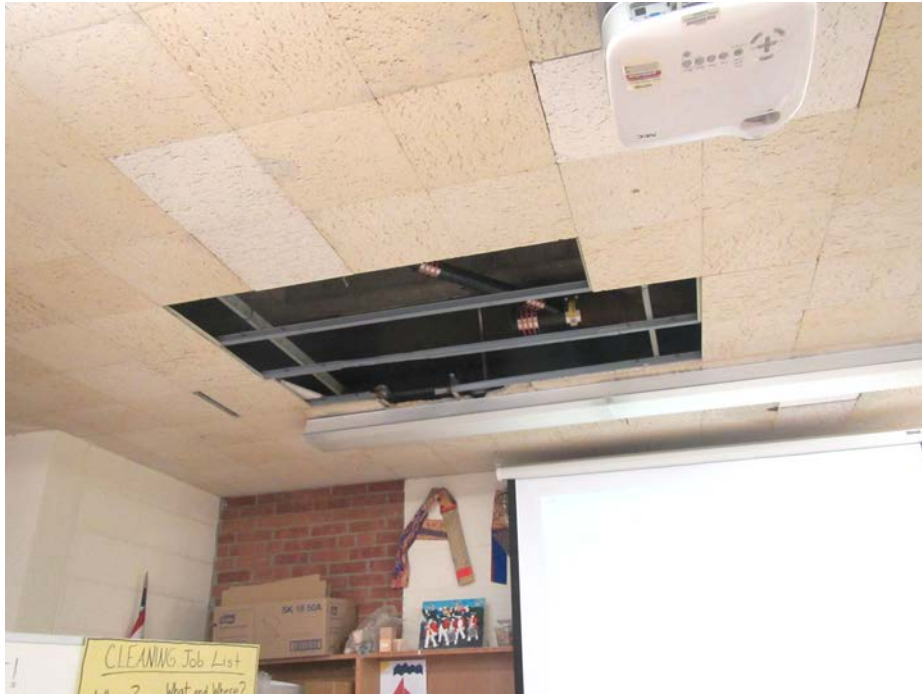
**Picture 9**

Missing ceiling tiles were observed in the art room (Picture 9), reportedly from a separate water leak. These ceiling tiles were also scheduled for replacement. Missing and ajar ceiling tiles can allow dust and debris from the ceiling plenum system to migrate into occupant spaces. All ceiling tile systems should be intact and flush.

**Missing ceiling tiles in art room**

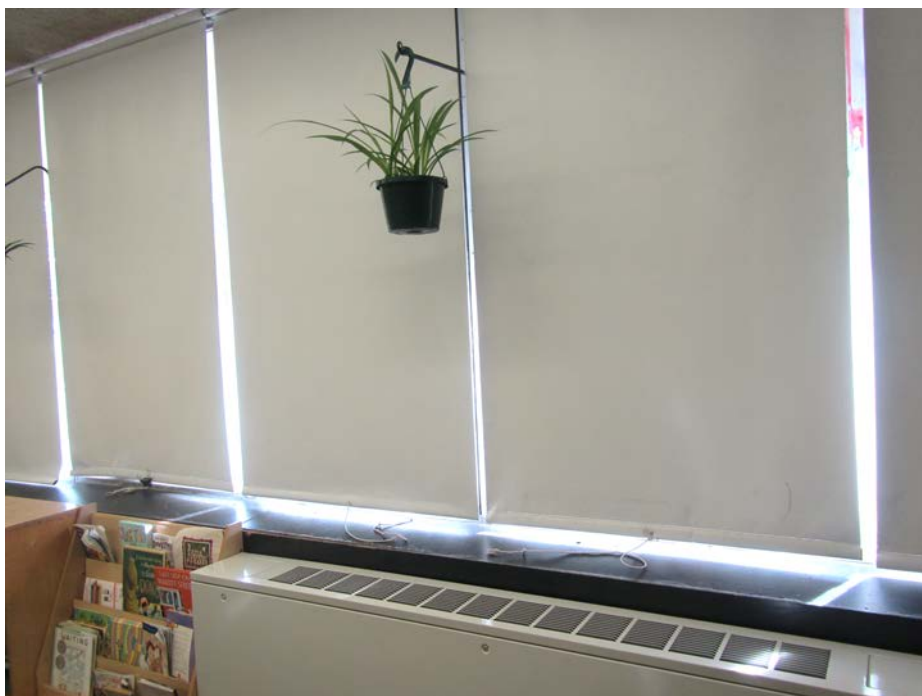
**Picture 10**

Several classrooms contained plants (Table 1). In one instance, a plant was observed suspended over a univent (Picture 10). Plants can be a source of pollen and mold, which can be respiratory irritants to some individuals. Plants should be properly maintained and equipped with drip pans to prevent water damage to porous materials. Plants should also be located away from air diffusers to prevent the aerosolization of dirt, pollen, and mold.

**Plant hanging over unit**

16. Move plants away from univents in classrooms. Avoid over-watering and examine drip pans periodically for mold growth. Disinfect with an appropriate antimicrobial where necessary.

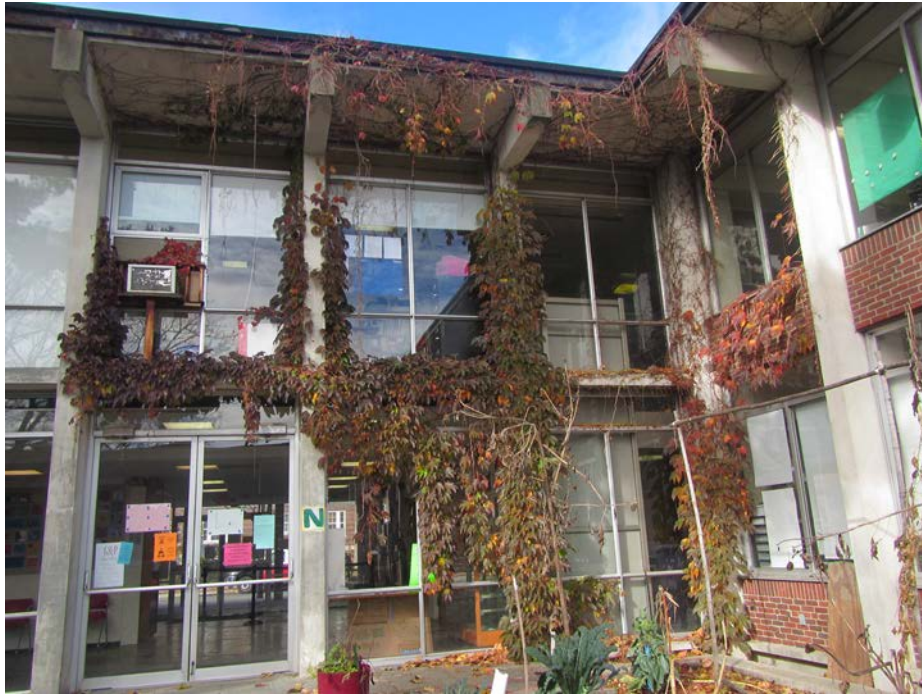
**Picture 11**

Plant vines were observed on the building's exterior (Picture 11). Roots growing into the brick mortar can create fissures, which can cause crumbling and deterioration of the building

exterior due to freezing and thawing of water trapped in these spaces. Over time, water can enter the building through damage to the exterior wall.

**Vine growth against building exterior**

17. Remove plants growing against the exterior wall/foundation of the building to prevent water penetration.
18. Examine and consider removing ivy/vine growth on exterior walls to prevent damage.

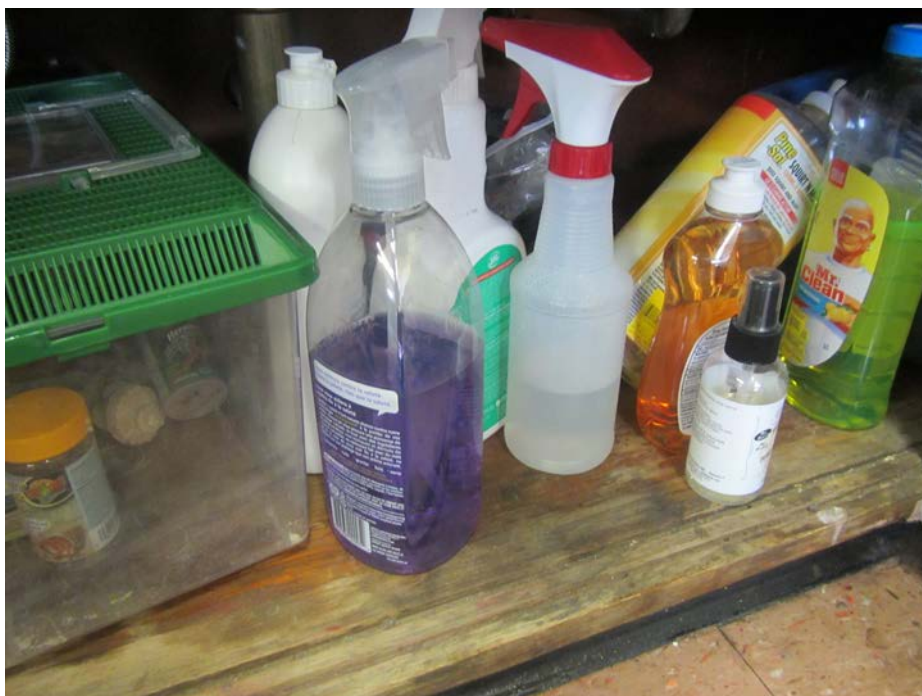
**Picture 12**

It is important to note that many of the cleaning products used in the school are not consistent with products used by the cleaning staff. In some cases, cleaning products were placed in unlabeled bottles. Measures should be taken to ensure cleaning products used by teaching staff are consistent with those used during housekeeping. In addition, safety data sheets (SDSs) should be available at the school.

**Variety of cleaning products, note unlabeled bottle**

22. Consider supplying teaching staff with cleaning products consistent with those used with the Cambridge Public Schools Facilities Department. Ensure SDSs are available.

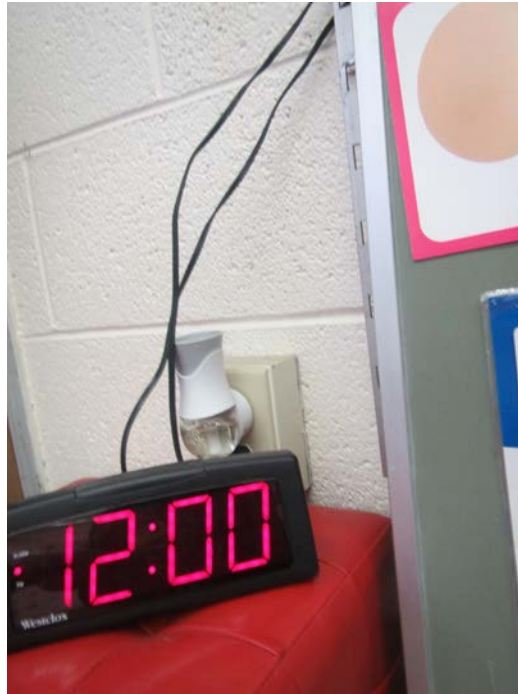
**Picture 13**

**Plug-in air deodorizer**

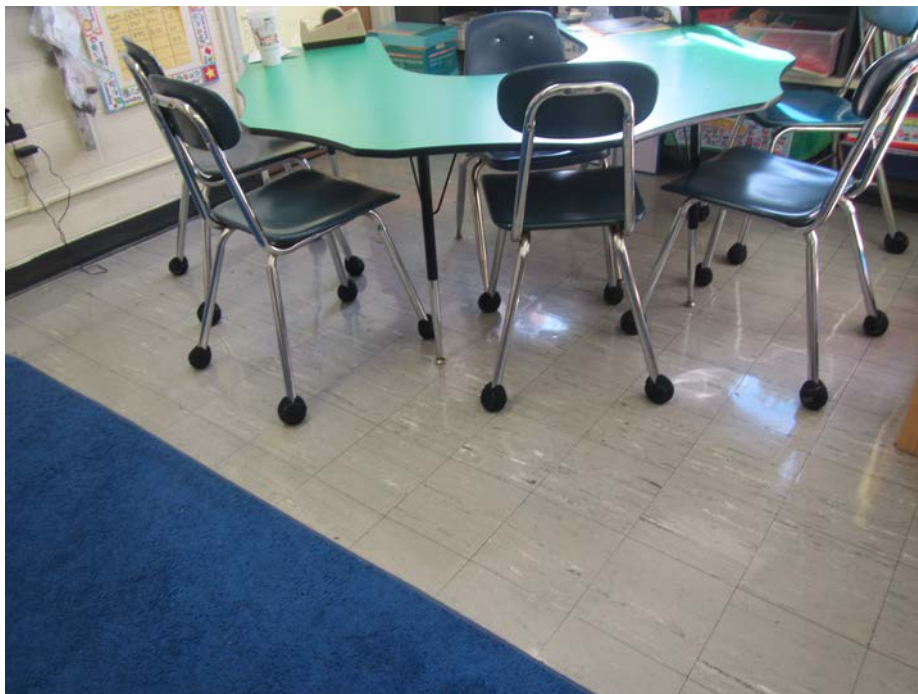
**Picture 14**

Tennis balls had been sliced open and placed on chair footings to reduce noise (Picture 14). Tennis balls are made of a number of materials that are a source of respiratory irritants. Constant wearing of tennis balls can produce fibers and lead to off-gassing of VOCs. Tennis balls are made with a natural rubber latex bladder, which becomes abraded when used as a chair leg pad. Use of tennis balls in this manner may introduce latex dust into the school environment. Some individuals are highly allergic to latex (e.g., spina bifida patients) (SBAA, 2001). It is recommended that the use of materials containing latex be limited in buildings to reduce the likelihood of symptoms in sensitive individuals (NIOSH, 1997; NIOSH, 1998).

**Tennis balls on chair legs**

23. Replace tennis balls on chair footings with latex-free glides.
24. Relocate or consider reducing the amount of materials stored in classrooms to allow for more thorough cleaning. Clean items regularly with a wet cloth or sponge to prevent excessive dust build-up.

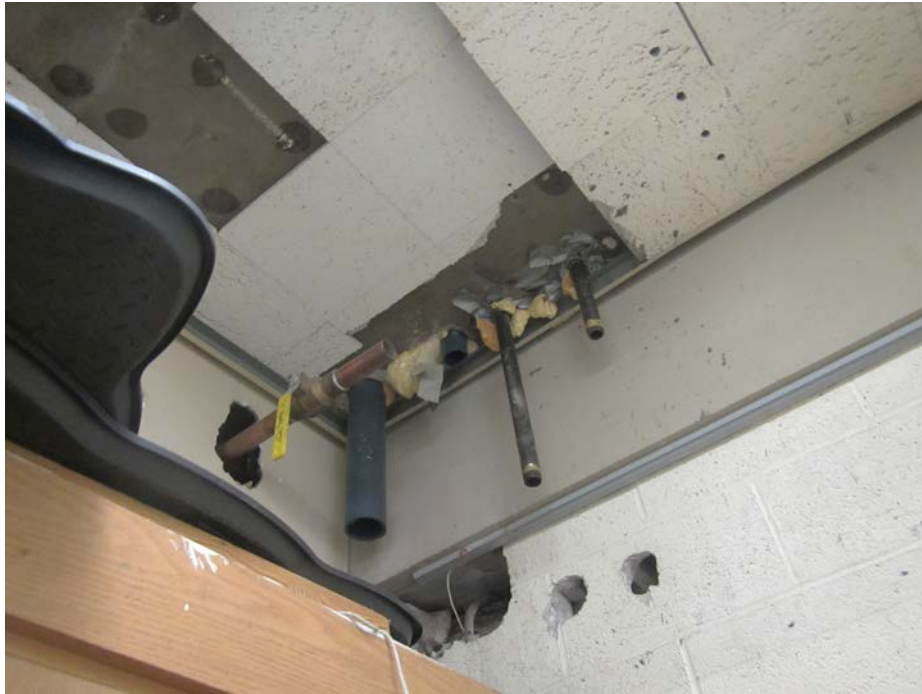
**Picture 15**

Pipe penetrations were observed in walls in a few areas (Picture 15). Walls for occupant areas should be finished. Any openings around pipes should be sealed to prevent migration of odors, dusts, and particulates. Abandoned pipe should also be capped.

**Wall openings and abandoned pipes**

29. Seal wall openings and cap abandoned pipes to prevent migration of odors and particulates.
30. Consider adopting the US EPA (2000) document, “Tools for Schools”, as an instrument for maintaining a good IAQ environment in the building. This document is available at: <https://www.epa.gov/iaq-schools>.
31. Refer to resource manual and other related IAQ documents located on the MDPH’s website for further building-wide evaluations and advice on maintaining public buildings. These documents are available at: <http://mass.gov/dph/iaq>.
